# Manhole Inspection Summary

Manhole # S13M\_\_006MH

**Location** Address: **200 FONTHILL AV**

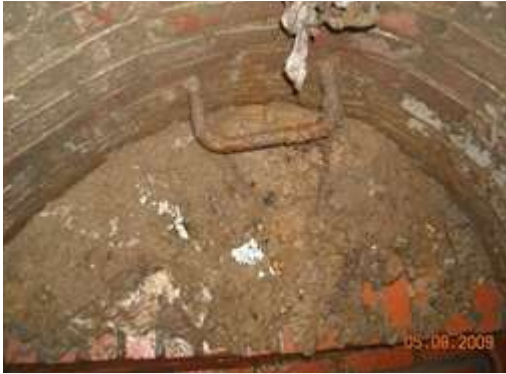
Defect 4

NO DIRT AROUND FRAME

DEBRIS ON BENCH

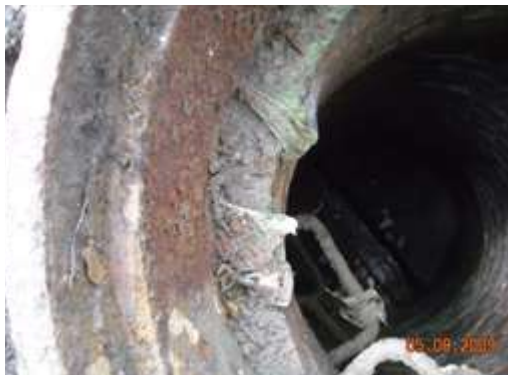
Defect 3

**Frame** Offset: **3** (in.) Condition: ☐ Sound ☐ Cracked ☒ **Leaks**

FRAME OFFSET

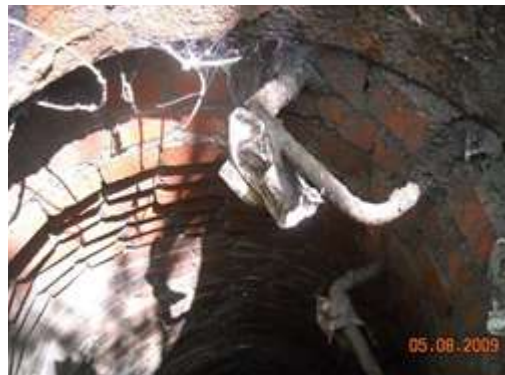
Defect 2

**Surcharge** ☒ **Evidence Of Surcharge** Depth: **10** (ft.) ☐ Active Surcharge Present

SURCHARGE EVIDENCE ON TOP STEP

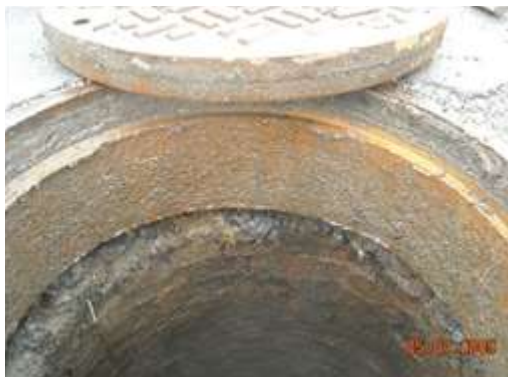
Defect 1

Condition: ☐ Sound ☐ Cracked ☐ Root Intrusion ☐ Loose Brick ☒ **Deteriorated**

Infiltration: ☐ None ☒ **Joint** ☐ Cracks ☐ Mortar ☐ Roots ☐ Wall

FRAME LEAKS, CORBEL  
DETERIORATING AND LEAKING AT  
JOINT

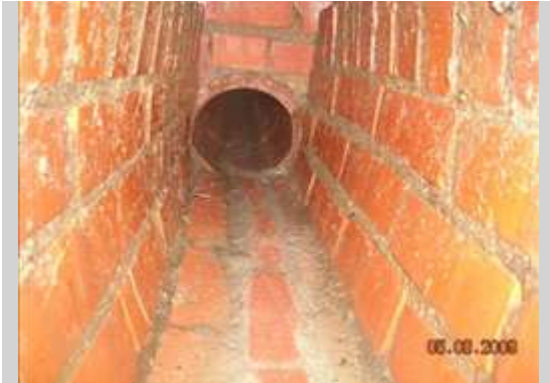
12 O'Clock Outflow

Pipe Height: **8.4** (in.) Rod and Bar (Angled)  
Pipe Material: **Clay** ☐ Pipe Lined  
Invert Depth: **12.08** (ft.) Flow Characteristics: **Slow**  
Deposits: ☒ None ☐ Mud ☐ Sludge ☐ Debris ☐ Grease  
Silt Depth: **0** (in.) Deposits Extent:  
Infiltration: **None** Pipe Seal Cond: **Sound**

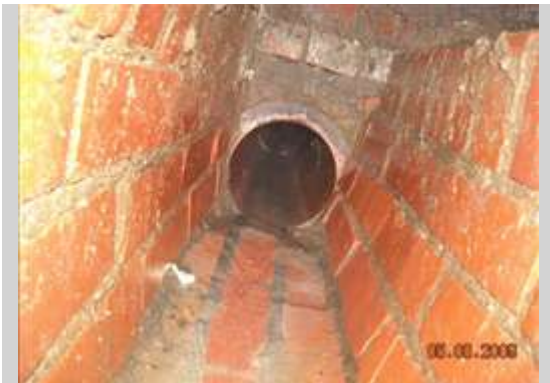
6 O'Clock Inflow

Pipe Height: **8.4** (in.) Rod and Bar (Angled)  
Pipe Material: **Clay** ☐ Pipe Lined  
Invert Depth: **11.95** (ft.) Flow Characteristics: **Slow**  
Deposits: ☒ None ☐ Mud ☐ Sludge ☐ Debris ☐ Grease  
Silt Depth: **0** (in.) Deposits Extent:  
Infiltration: **None** Pipe Seal Cond: **Sound**
